Summit at Fern Hill Community Development District

WORKSHOP AGENDA

FLORIDA INSURANCE ALLIANCE

Summit At Fern Hill Community Development District

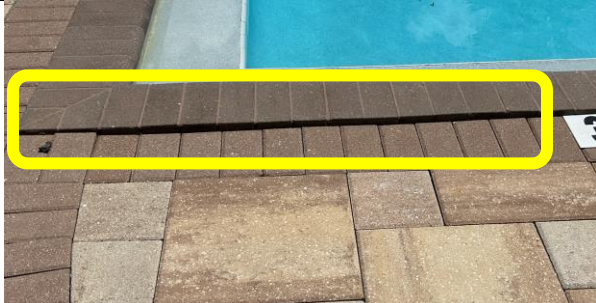
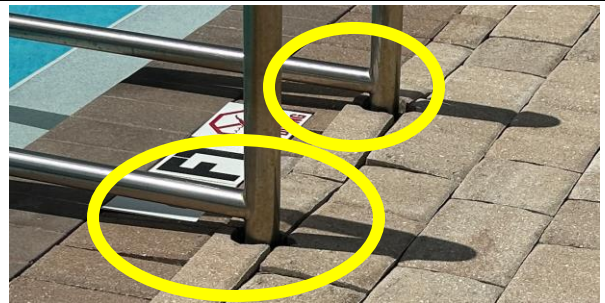
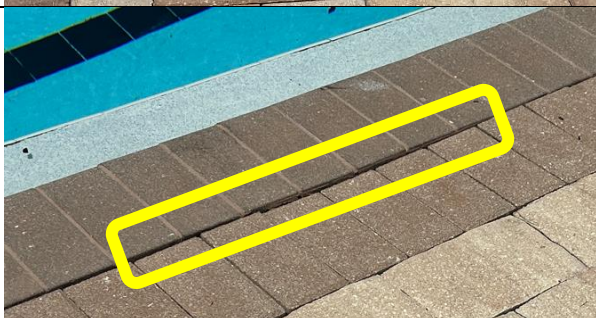
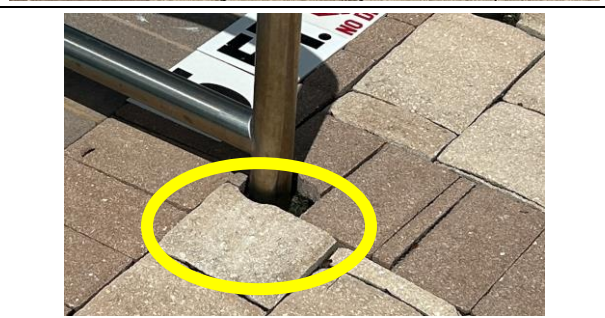
<p>Pool Pavers – Some areas of pool pavers appear to be sunken at least ¼” from the rest of the pavers and may present trip hazards. Gaps or holes over ½” near the pool ladders may allow toes to get caught and incur injury.</p>	<p>Please have a thorough inspection done of all areas of sunken or raised pavers and have them reset or repaired to be flush with the rest of paver surface to help reduce trip hazards. Gaps greater than ½” should be filled.</p>

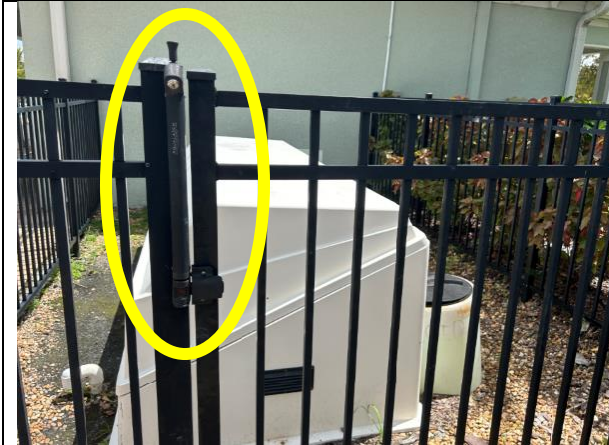
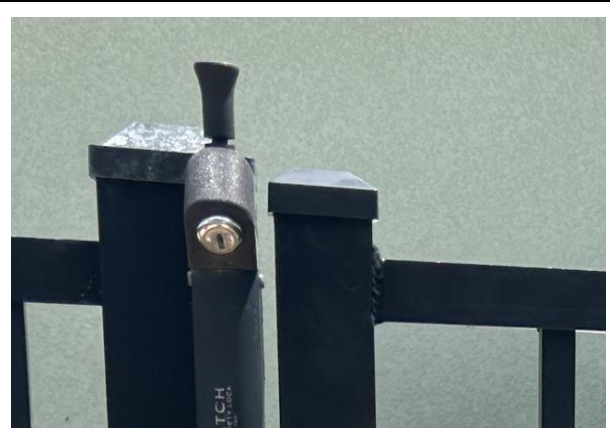
Access to Pool Chemicals – The gated area containing the pool pump equipment and chemical tanks was unlocked at the time of the site visit and may allow children to access hazardous chemicals and equipment enclosure entrapment hazards.

If the lock is broken on the gate, then consider adding a padlock or bike lock to this gate to prevent unauthorized access. If the gate is in working order but not locked by the vendor, please coordinate with the vendor closely to ensure the gate is always locked.

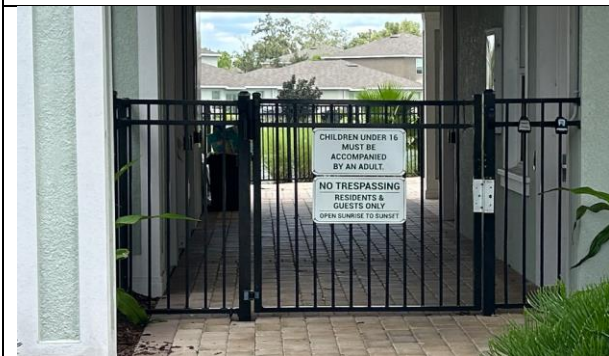
Pool Signage – The entry gates into the pool area lack ‘no lifeguard on duty’ signage to warn parents and guardians that children will not be monitored or supervised.

Although the ‘children under 16 must be accompanied by an adult’ is a helpful sign, having ‘no lifeguard on duty’ signage will enhance the awareness that children must be monitored and supervised in the pool area and is considered a best practice.

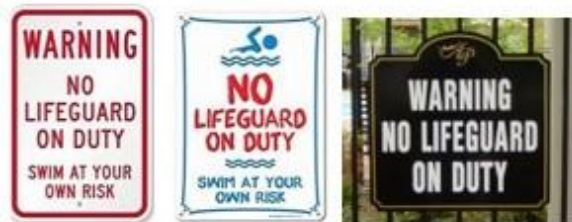
Example signage often seen at districts.

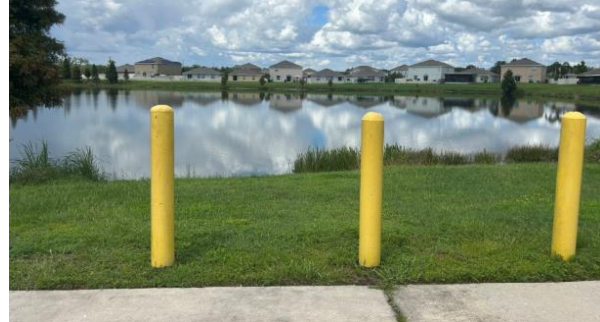
Pond Signage – Although the pond at the playground did have adequate signage warning of wildlife hazards, the other pond near the dog park had no signage.

As a best practice, consider reviewing all the ponds in the district for signage. If ponds are along well-traveled sidewalks, trails, or amenities then signage is recommended.

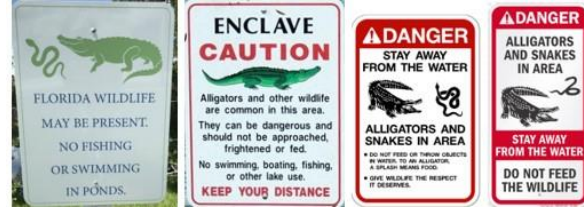
Example signage seen at other districts.

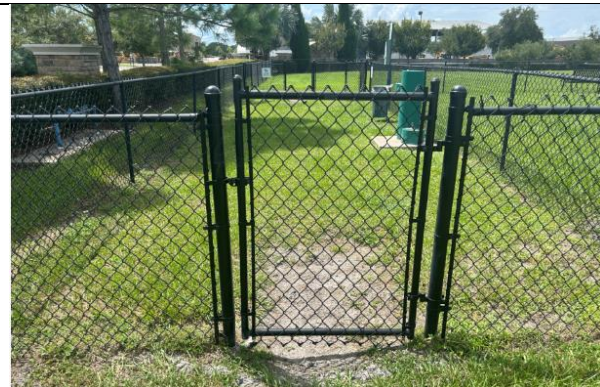
Dog Park – The district has adopted rules for community dog parks including age restrictions for children however there is no signage at the dog park reminding residents of the rules, policies, and warnings. There is no signage advising dog owners to use the amenity at their own risk. Areas of the fencing have some gaps that should be closed to prevent escapes. Holes dug should be filled in to prevent trips and falls.

Consider posting signage at the dog park reminding residents of guests of the rules for continued safe use of the parks. An example is included below. Also consider updating the Recreation Facilities Policies to include language in the dog park section reminding residents that dog park use is at their own risk. Include this verbiage on signage as well. Please review the attached handout for more comprehensive guidance on this amenity.

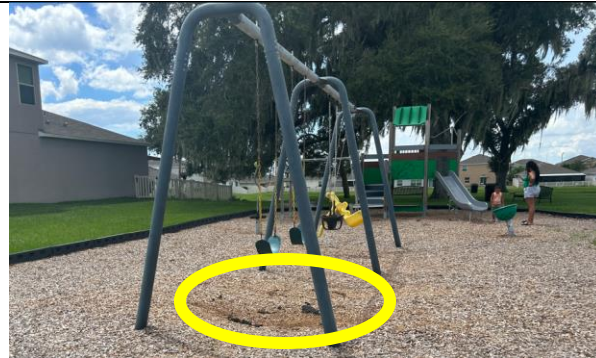
Playground – The playground has no observable rules, policies or guidance signage nor any decals noting specific age limits or warnings (hot surfaces, etc.). Landscape fabric is exposed, and possibly may cause a trip and fall. Fall surfacing does not appear to meet recommended depths.

Please review the attached handout regarding playground maintenance and inspections. Increase mulch depths as needed where falls from heights are probable. Consider adding signage that covers age appropriateness of the equipment and warnings.

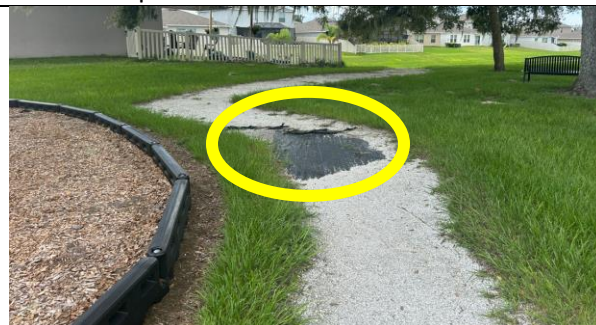
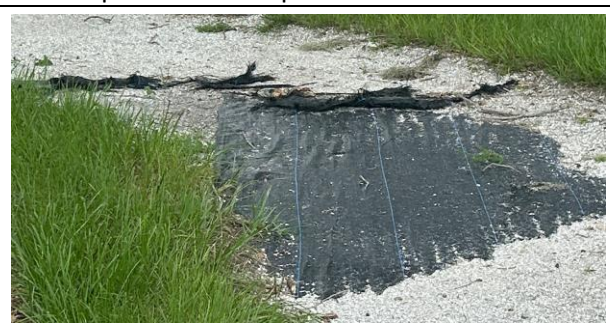
Trail – The crushed-shell trail that starts at the playground and winds out to the pond has exposed landscape fabric that could be a trip hazard for patrons.

Please review the attached trails handout for best practices in maintaining trails. Consider adding more crushed shell after burying the landscape fabric to help reduce falls.
